No.		1/2
N°	AL-2003-02	
Date	2003-03-12

## ***SERVICE DIFFICULTY ALERT***

### **BEECH C90 SERIES**

#### **CRACKED SPAR FITTING**

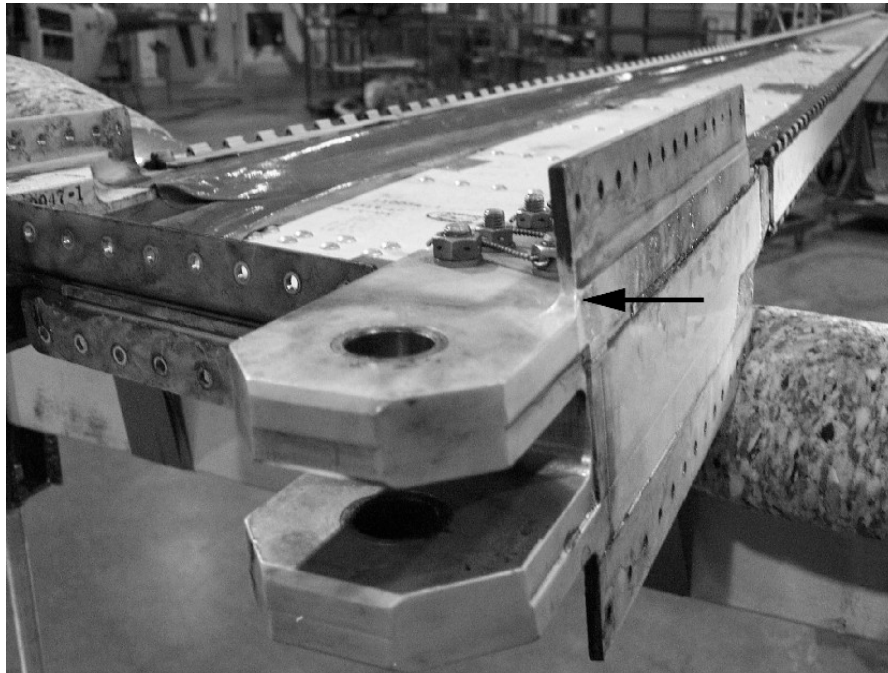
**Figure A**

**CRACK ON SPAR IS LOCATED AT THE FORWARD BOTTOM L/H FITTING  
CRIQUE DU LONGERON SITUÉE SUR LA FIXATION INFÉRIEURE AVANT GAUCHE**

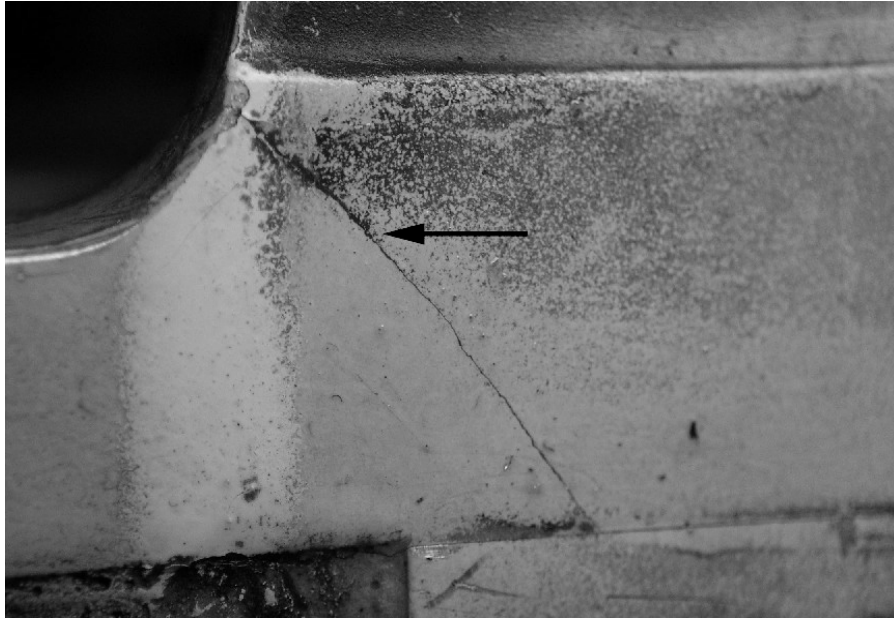
**Figure B**

During the wing bolt replacement procedure, an AME noticed an oily streak on the lower spar fitting. After cleaning and further inspection, it initially appeared to be a deep scratch. Liquid Penetrant Inspection was performed, and the crack was revealed. The crack extends from the bottom of the fitting vertically 0.549" and diagonally 0.760" through the first section of the bottom-bonded lug. (See fig. B)

Au cours d'une procédure de remplacement du boulon d'aile, un TEA a remarqué une rayure huileuse sur la fixation inférieure du longeron. Après un nettoyage et une inspection plus poussée, il a semblé au départ qu'il s'agissait d'une profonde égratignure. Un essai par ressuage a été effectué, et il a été possible de confirmer l'existence d'une crique. La crique, qui prenait naissance au bas de la fixation, s'étendait à la verticale sur 0,549 po et sur 0,760 po en diagonale en travers de la première section de la patte de fixation inférieure (voir figure B).

FAA Airworthiness Directive 89-25-10 and Transport Canada CF-1981-25R6 calls for attention to this area for a limited range of serial numbered aircraft. This crack occurred on an aircraft outside this range. However, the spar wing attachment inspection of this area is covered by the Beech Structural Inspection Repair Manual (SIRM).

The operator has advised Transport Canada that they have been instructed by Raytheon (Beech) to replace the entire spar as a result of this damage. The spar has been shipped to the manufacture for further analysis. The FAA has been advised of this issue and an investigation is in progress.

Transport Canada strongly recommends that operators and maintainers of Beech C90 series aircraft inspect this area for cracks at their earliest opportunity. Transport Canada also reminds AMEs to remain vigilant while inspecting this area during scheduled maintenance.

Transports Canada recommande fortement aux exploitants et au personnel de maintenance des avions Beech C90 de procéder, le plus tôt possible, à une inspection de cette région afin d'y déceler d'éventuelles criques. Transports Canada rappelle aussi aux TEA de demeurer vigilants lorsqu'ils inspectent cette région pendant la maintenance périodique.
